LOURENÇO T, MATIAS L, FARIA P (2017), Anomalies detection in adhesive wall tiling systems by infrared thermography. Construction and Building Materials, 148, 419-428 (September 2017), <https://doi.org/10.1016/j.conbuildmat.2017.05.052>

Anomalies detection in adhesive wall tiling systems by infrared thermography

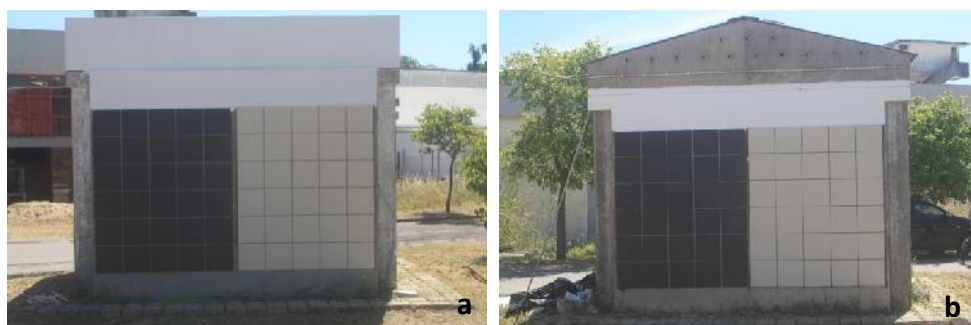
Four tiled panels were applied on two West facing facades (figure 1) of two experimental cells situated in National Laboratory for Civil Engineering (LNEC) Campus, Lisbon, Portugal. Panels have differences in terms of the tiles' colour and kind of support. Cell 1 tiled panels were applied as finishing coating of ETICS (External Thermal Insulating Composite System). Therefore, a thermal insulation is beneath the tiling system. Cell 2 tiled panels were applied on a traditional solution of a brick masonry cementitious regularization render. Each cell had then two panels, one with black tiles (on the left) and one with white tiles (on the right).

Figure 1 – Experimental cell 1 (a) and experimental cell 2 (b)

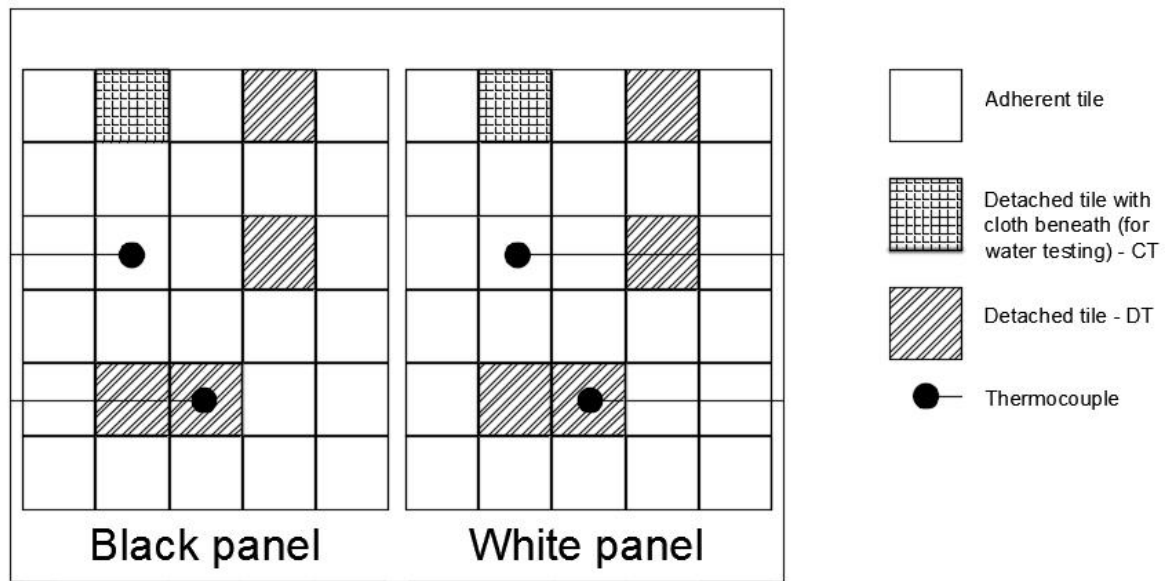
The positioning of the detached tiles within each panel is the same for all the four panels according to the scheme on figure 3. On the same figure, it is possible to see the positioning of thermocouples type T - Copper/Constantan - that were placed beneath the tiles, in the adhesive layer, in order to allow continuously reading of temperatures and, therefore, reinforce the thermographic data. Those

Figure 3 – Schematic representation of the panels with the detached anomalies and instrumentation

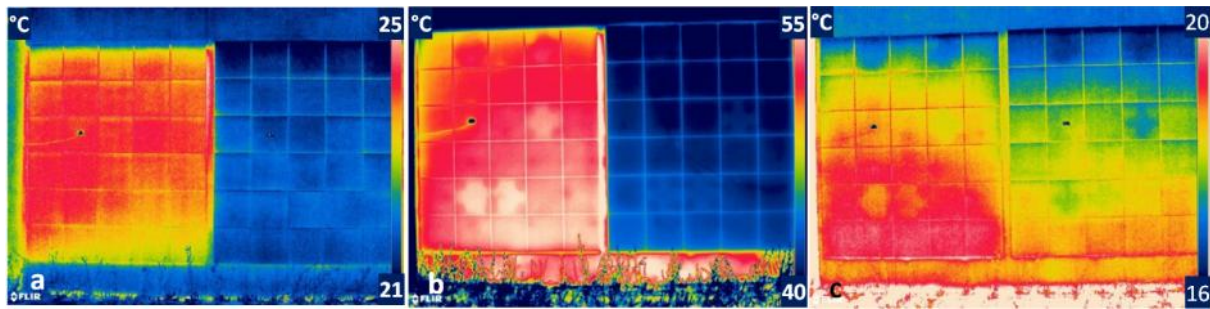
Figure 4 - C1 (ETICS) at 9:30 am (a); 3:30 pm (b) and 10:15 pm (c)

As a first result of this survey, figures 4 and 5 show two sequences of thermograms where the thermal variations during the same day are presented for each experimental studied cell. Therefore, on figure 4 there are three general thermograms: the first in the morning - before solar incidence (air temperature: 24°C); the second after one hour of solar incidence (air temperature: 30°C) and the third at night - cooldown period (air temperature: 21°C) of the experimental cell 1. In each case the black panel (C1_B) is on the left and the white panel (C1_W) is on the right. Similarly, figure 5 contains three thermograms, each with a black panel (C2_B) on the left and a white panel on the right (C2_W). In the thermograms, black panels appear in reddish colours due to the higher emitted temperature when compared with the white panels (represented in bluish colours). The temperature scale had to be adopted to each thermogram containing both black and white panels (with major thermal differences between them), which compromises the visibility of smaller thermal differences such as the ones that suggest anomalies. As mentioned, for analysis purposes two thermograms per panel were taken from closer distances allowing a narrower scale adoption and, therefore, facilitating the anomalous spots visualization. It is of note that thermograms from figure 4 and 5 are not in the same

- In the morning period, without solar incidence, the thermal differential between panels with different colours is attributed to diffuse radiation as both tiles are made out of the same material and the roughness is similar. Furthermore, the tiles' emittance value, carefully measured in laboratory for both the two colours, was the same (0.88) [31].
- Temperatures obtained for cell 1 (with thermal insulation of the ETICS) are higher than the ones registered on cell 2 (without thermal insulation).
- Anomalies detection is easier on cell 2.
- In the heating phase (two first thermograms) the detached tiles are hotter than the adherent ones; contrariwise, on the cooldown phase, detachments are presented as colder spots.

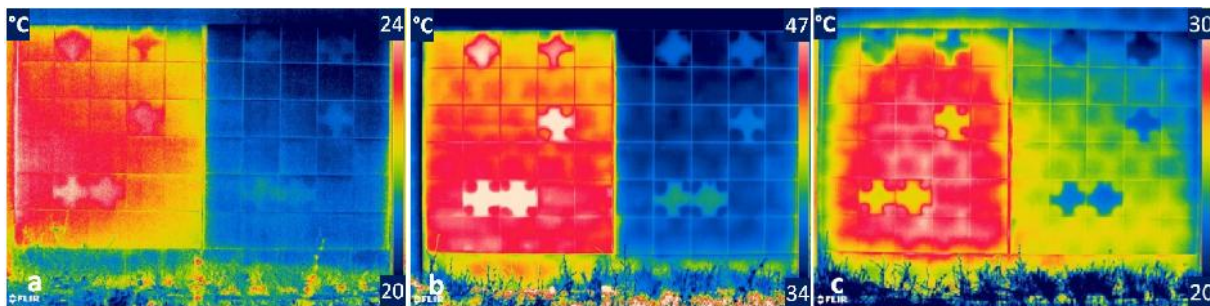
Figure 5 - C2 (rendering system) at 9:30 am (a); 3:30 pm (b) and 10:15 pm (c)

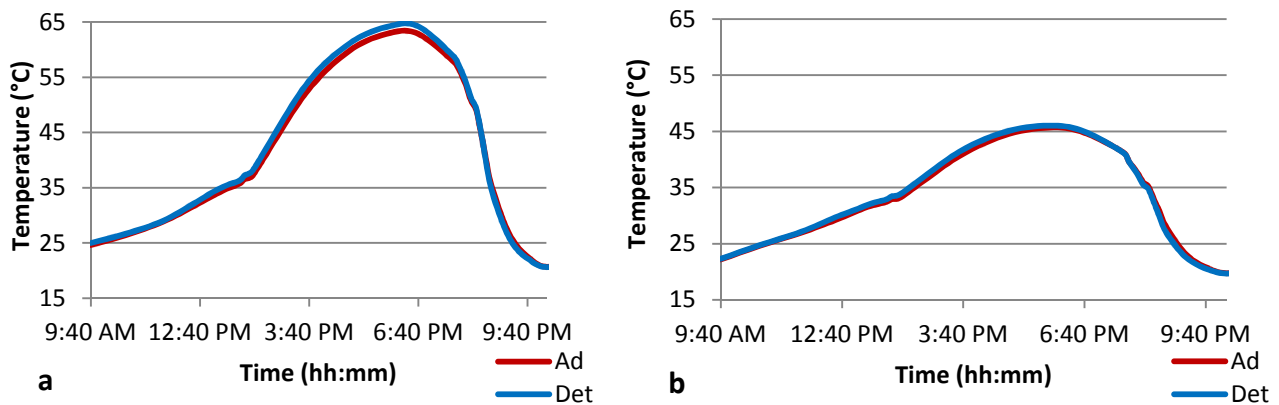
Figure 6 - Evolution of adherent (Ad) and detached (Det) tile's average temperatures in **cell 1's**

black panel (a) and white panel (b)

In order to study numerically the thermal variations in both the detached and adherent tiles of each panel, the graphics of figures 6 and 7 were created for the 20th July 2016. The temperatures presented in the graphics were obtained by measuring each tile's average temperature (area of tile) and afterwards calculating average temperatures for both the adherent and detached tiles of each panel, resulting in two curves per panel.

Analysing both the thermograms and the graphics that describe the evolutions of the temperatures obtained for the detached (Det) and adherent (Ad) tiles it is possible to take some similar conclusions regarding the cladding's behaviour.

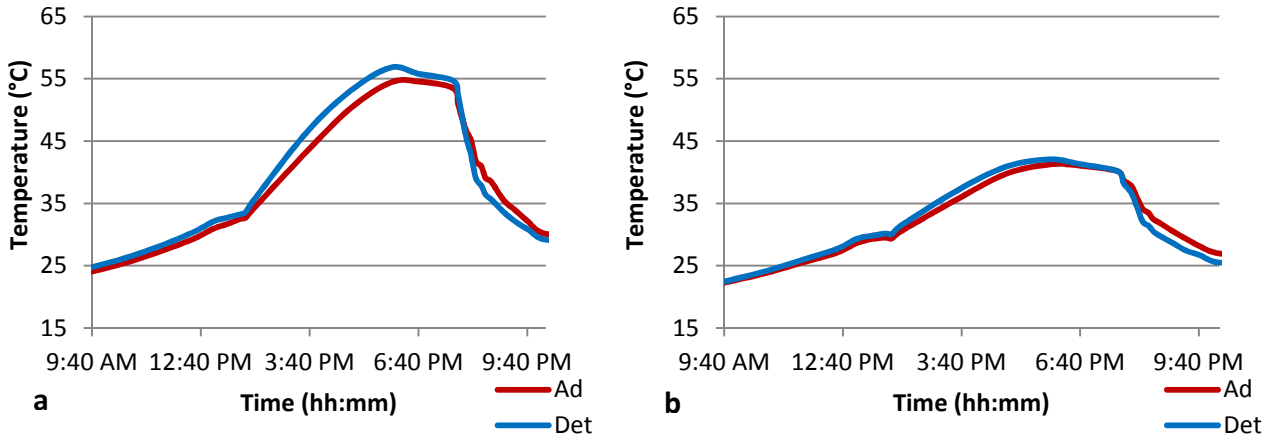
Figure 7 - Evolution of adherent (Ad) and detached (Det) tile's average temperatures in **cell 2's** black panel (a) and white panel (b)

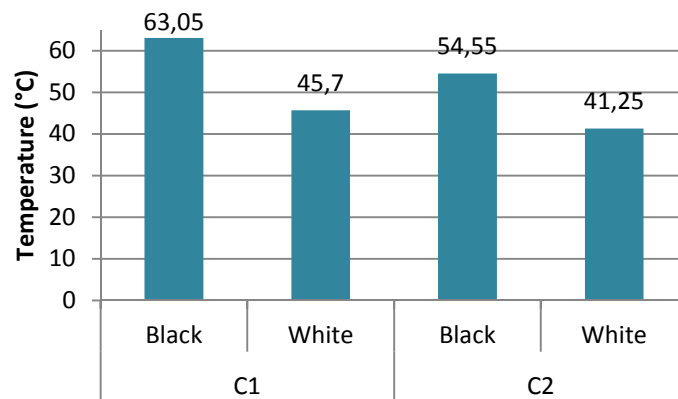
Figure 8 - Maximum average temperatures obtained in all panels' adherent tiles

When the differences between adherent tiles of both colours are analysed, as expected and seen in the thermograms, black panels reach higher temperatures than white panels (about 17°C above on cell 1 and 13°C above on cell 2).

Regarding the differences between the two cells, i.e. between the two supports, the ETICS solution reaches higher temperatures. In the case of black panels, ETICS based panels' temperatures are 9°C higher, while in the case of white panels the difference is 4°C.

Observing figure 8 it is possible to compare adherent tiles' maximum temperatures verified during

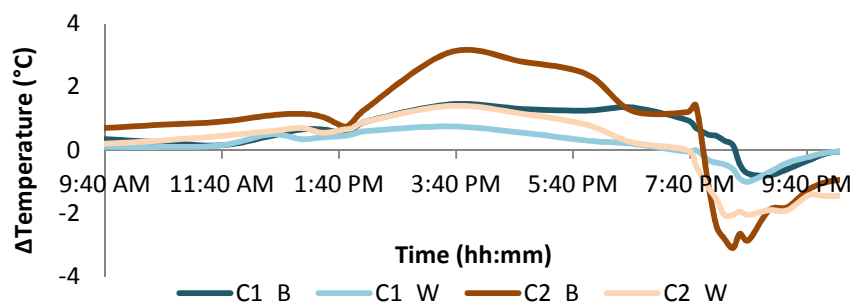
Figure 9 - Thermal differentials between detached and adherent tiles

Analysing Figure 9 it is possible to distinguish the existence of different phases:

- The differential drops slowly until 7:30 pm
- With the panels' cooldown, the differential changes from a positive value (detachments' temperatures higher) to a negative value (detachments' temperatures lower).
- While temperature drops and the sun sets the differential also drops reaching its minimum at around 8:30 pm.
- After reaching the minimum the differential fades, making it more difficult to visualize the anomalies.

Figure 9 shows the variation of the thermal differential between detachent and adherent tiles with time.

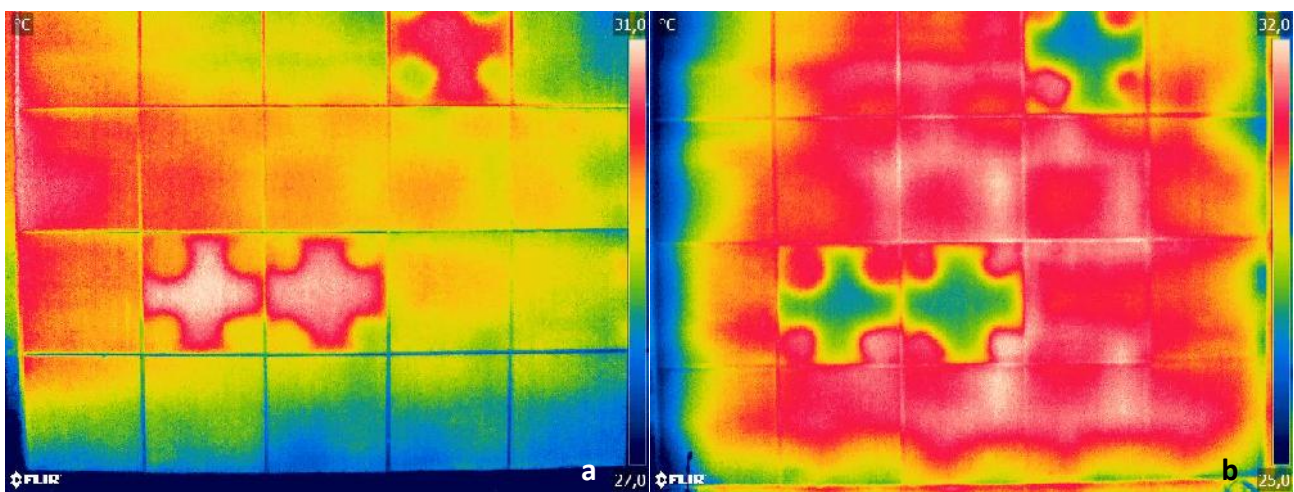
Figure 10 – Thermograms from the bottom half of cell 2's black panel taken during the day (a) and at night (b)

In these thermograms, taken from a closer distance to the panels, it is possible to verify that, as shown before on the quantitative analysis, the thermal differential is positive during the heating phase (day) and negative after some time of cooldown (night) ; ie in the first thermogram it is possible to see higher temperatures in the detached tiles (reddish / whitish coloured in the thermogram) and in the second the opposite, as detached tiles are colder (blueish).

Figure 10 presents two thermograms taken to the bottom half of the black panel from cell 2 (C2_B) taken during the day (maximum differential – 3:30 pm) and at night (minimum differential – 10:15 pm).

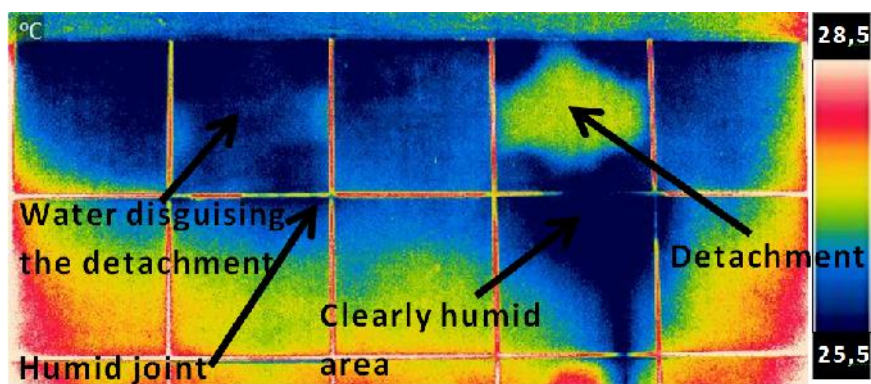
Figure 12 - Thermogram taken from C2_W at 12 pm - The classification of the anomalous tiles is presented in table 1, where CT (second from the left) is classified with a 4 and DT (fourth from the left) with a 6

- Despite, as mentioned, every tile having verified some water leakage from the joints, being classified as so in the thermograms taken 30 min after the injection, the leakage from C1_B's CT did not appear visible on the thermogram.
- Tiles with a cloth beneath (CT) verified in general both presence of water making it difficult to detect the detachments and presence of water in the joint and surroundings (figures 12 and 13).
- Simply detached tiles in general presented a wide humid area after the injection, sometimes partially disguising the detachments (only partially because the water was only present in the

bottom half of the tile: figure 12).

In a first analysis, it is easy to identify the effect of moisture beneath tiles in these two thermograms. Comparing the results obtained with the “dry results” (figures 4 and 5) the main conclusion is that

water lowers the cladding's temperature resulting, for example, in a cooler area (bluish area in the thermogram), such as the one identified as "clearly humid area" in figure 4. In some cases, especially when there is a cloth beneath the detached tile, the water lowers the tile's temperature hindering the differential expected.

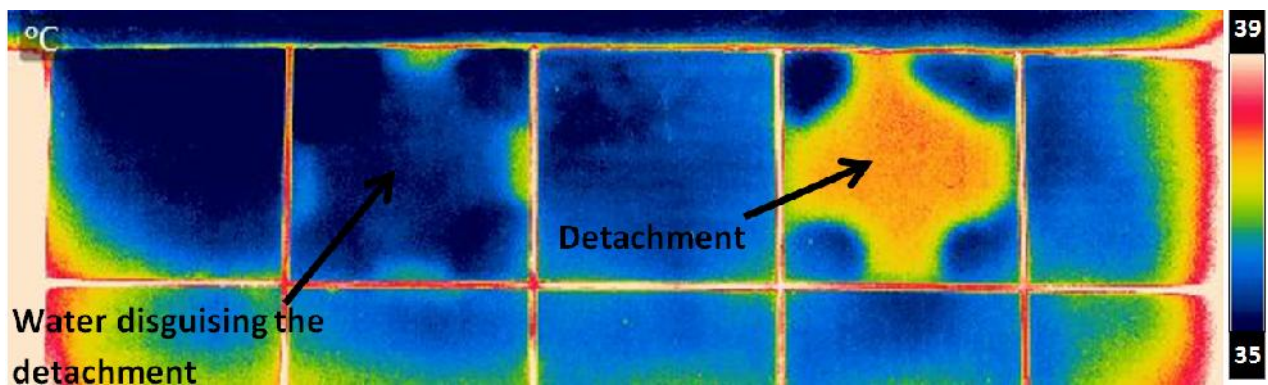
Figure 13 - Thermogram taken from C2_W at 3 pm - The classification of the anomalous tiles is presented in table 1, where CT (second from the left) is classified with a 4&5 and DT (fourth from the left) with a 3
